# Best Practice Guidelines

## Artificial Bank Creation for Sand Martins and Kingfishers

Laura Hopkins  
Assistant Conservation Officer  
The Environment Agency  
May 2001

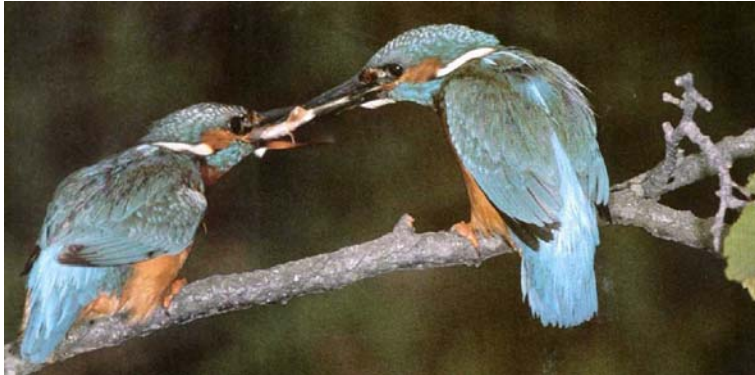
(Holmes 1985)

The nest tunnel is excavated by both parents usually 1-2m above the normal water level. It is horizontal or upward sloping and as much as 1m in length. It takes 7-12 days to create and two and very occasionally three broods may be reared in a single season. (Andrews and Kinsman 1990).

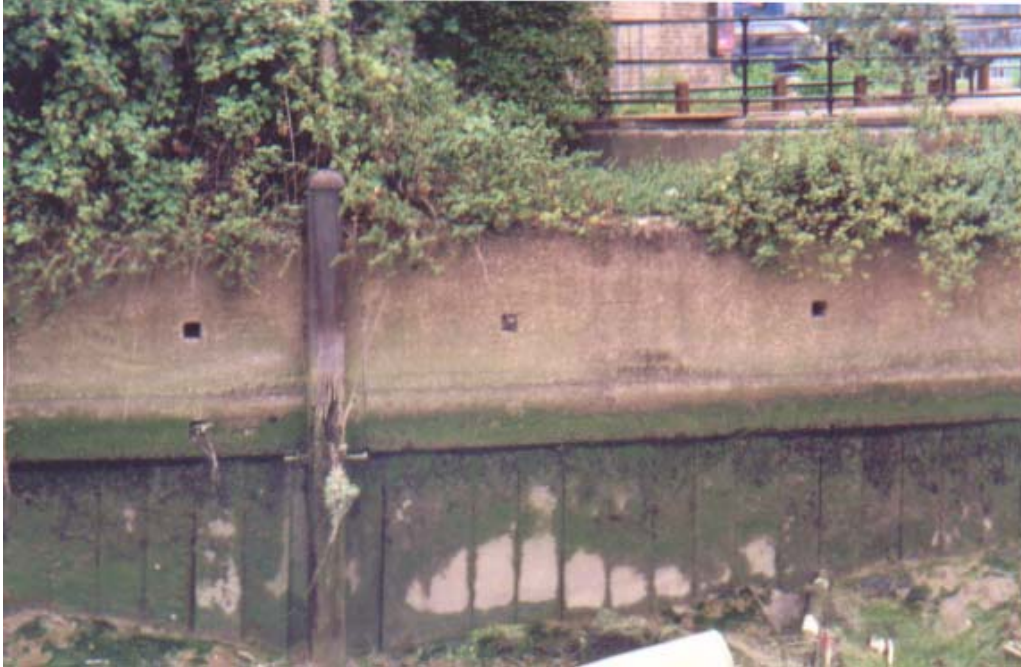
#### **Case Study 1**

Within the concrete channel drainage holes present in the walls have been used by Sand Martins to access the earth banks behind.

This example was not created for Sand Martins but is a good example of their opportunistic nature and ability to make use of man made structures.

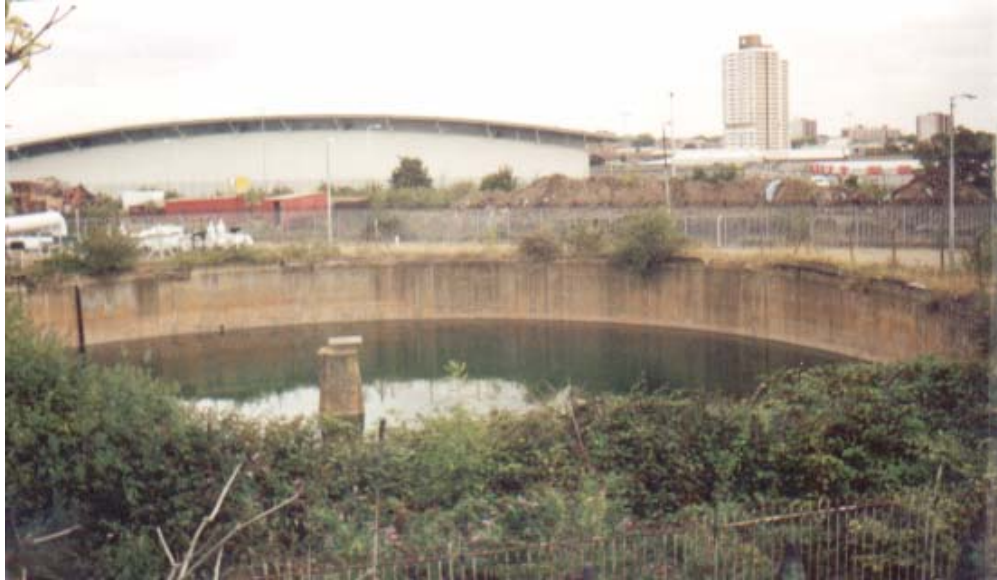
## Case Study 2

This old separating pond similar to the above example is also being used by Sand Martins who are again taking advantage of man made holes in the wall structure.

This also is an example that was not created for Sand Martins but illustrates their opportunistic nature and ability to make use of man made structures.

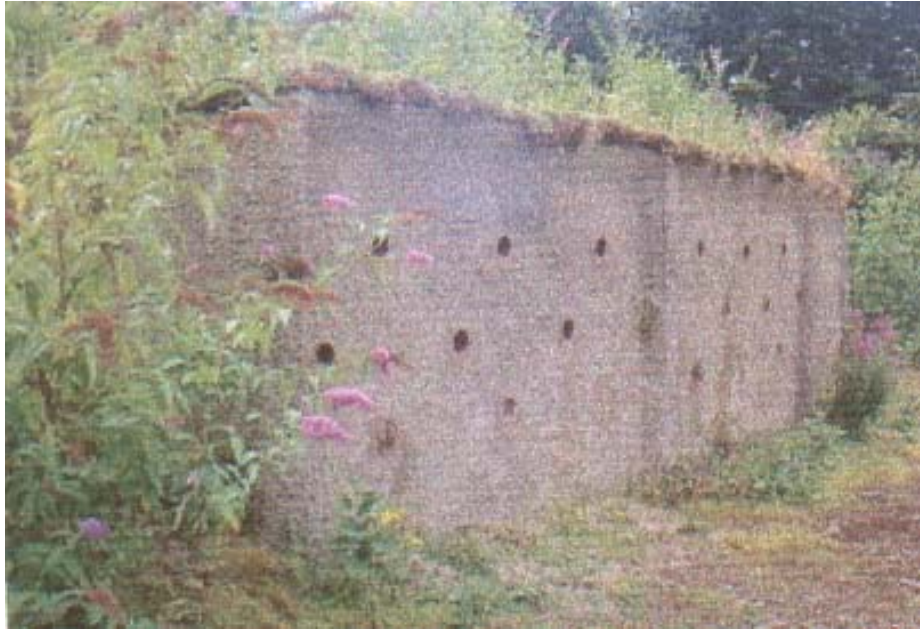
## Case Study 3

This sand martin Cliff was built as a result of summer flash floods inundating a natural sand cliff nesting site on the River Taff in 1996. It was built in the winter of 1996/97. It faces due north and is four metres from the artificial lake. The Cliff can be viewed from a bird hide.

The cliff is curved, 12 metres long and 1.8 metres high and has forty access holes.

It has an overhanging lip to shed rain and is finished in a tyrolean render. See Appendix p27 for details.

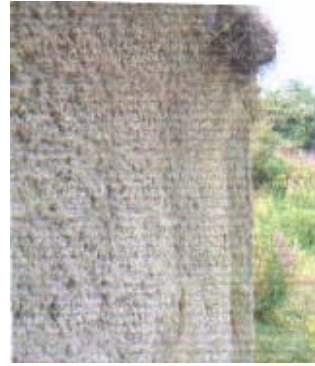
One metre lengths of 100mm ceramic sewer pipe built into the structure with a slope of 1/60 to the front for drainage. At the end of each pipe is a standard bag of builder's sand (40g) that is laid down in layers. As the wall is back filled the plastic bag is removed

when the next layer of fill is applied. The holes are refilled with sand before each nesting season.

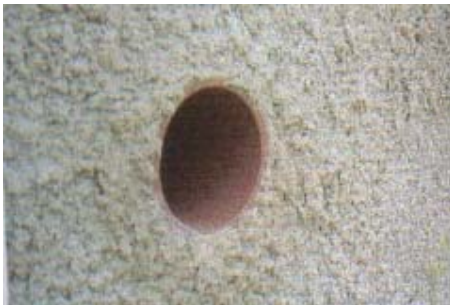
The holes are in three rows at 800mm horizontal spacing and 450mm vertical spacing in a checkerboard pattern. The bottom row is 550mm above ground level.

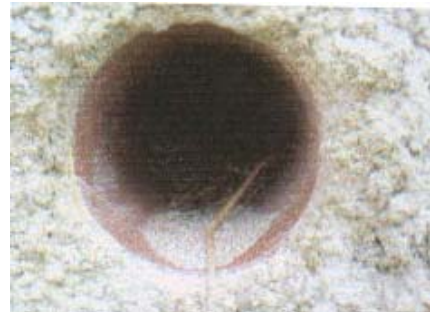
(Kent 2000)

It has been successful every year except 1999 when a late snowstorm caused the birds to leave prior to nesting. The spacing seems correct as all the top two rows of holes are used. There were 19 pairs in the year 2000 using the bank.

The bottom row of holes has never been used suggesting that they are too close to the ground. The construction technique is not recommended for others as it does not use standard materials and is technically complicated. A better technique to use would be to use conventional block work retaining wall techniques with a render coat like this example.

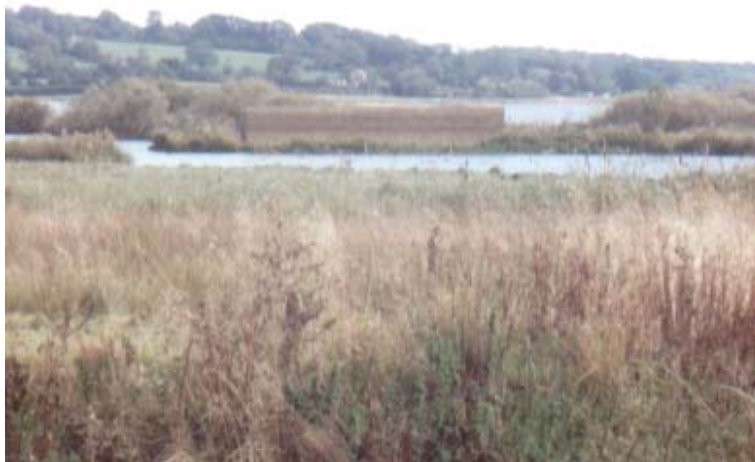
Fig 1

The site, on the bund on lagoon II was chosen after careful consideration (fig 1). The area was dug out down to water level, hardcored, with 50 mm clean limestone, rolled, then covered with 6 inches of reinforced concrete 8ft wide by 50ft long (fig 2).

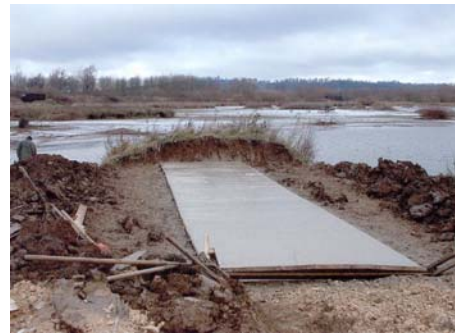
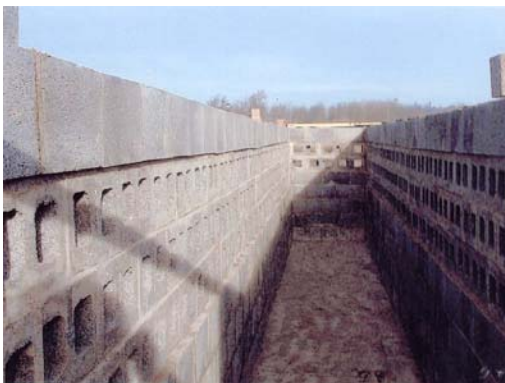
Fig 2

The bank was then constructed using 9 in x 18 in hollow concrete blocks. Two blocks were laid side by side for four courses, and then the blocks were turned on their side giving an 18 in deep hole (fig 2). There were four walls, two at 43ft long, one at 6 ft long, and the end wall at 6 ft but with a 2ft 6 in doorway (fig 2 and 4)

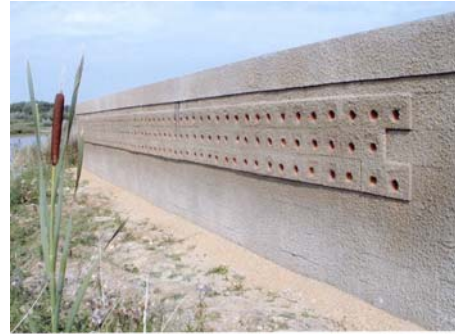
Fig 3

The holes then had 3 in x 12 in clay pipes inserted, which were cemented in, giving a 6 in compartment at the back. Each of these compartments had a door fitted on the inside of the building. There were 347 holes (fig 3 showing one wall of holes).

These holes were then filled with sand and later raked out. A pattern of two full, two half full and two empty which was continued on all 347 holes.

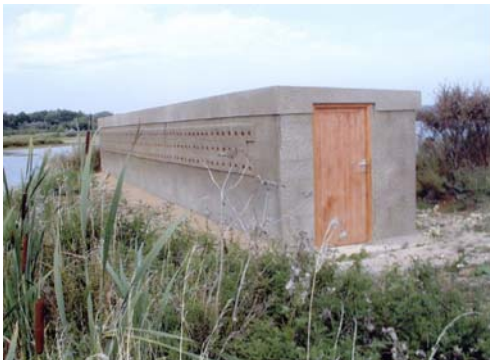
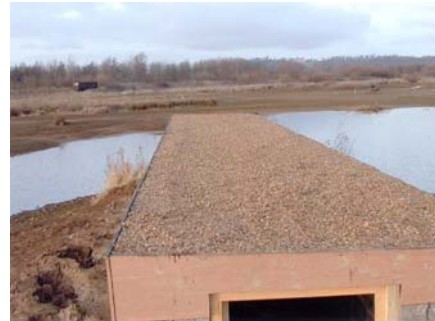
Fig 5

The front, back and end were Tyrolean rendered (fig 3). The roof was constructed of 4ft x 2 in roof beams with 8ft x 4ft Far Eastern Ply on top. Hot tar was then poured on top of the ply, and covered with gravel (fig 5).

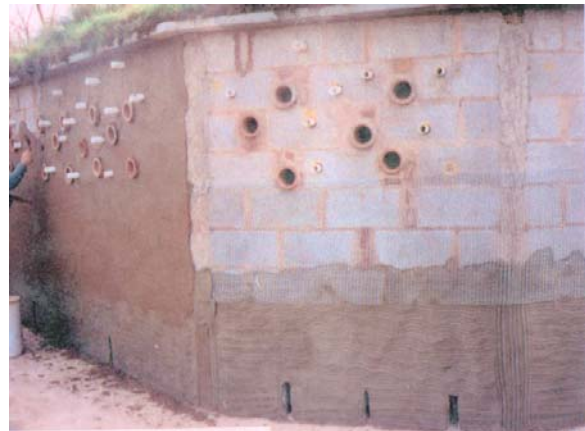
(Goodrich 1993)

At the back of the bank it was filled up to 1.2m high by 1m deep with large stone to help with drainage, then the remainder was compacted material suitable for sand martins to excavate for their nests. It then had a covering of Teram to help prevent rabbits etc digging in to it, and finally topped with a row of slabs. The ends of the bank consisted of stacked sand

bags filled with sand and cement.

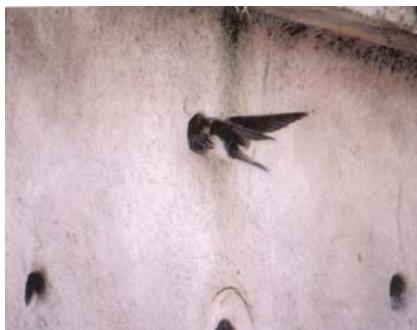
There were two different types of nesting holes, one being 100mm clay pipes and the others 40mm drilled holes through the concrete blocks (this was done before the blocks were filled with concrete).

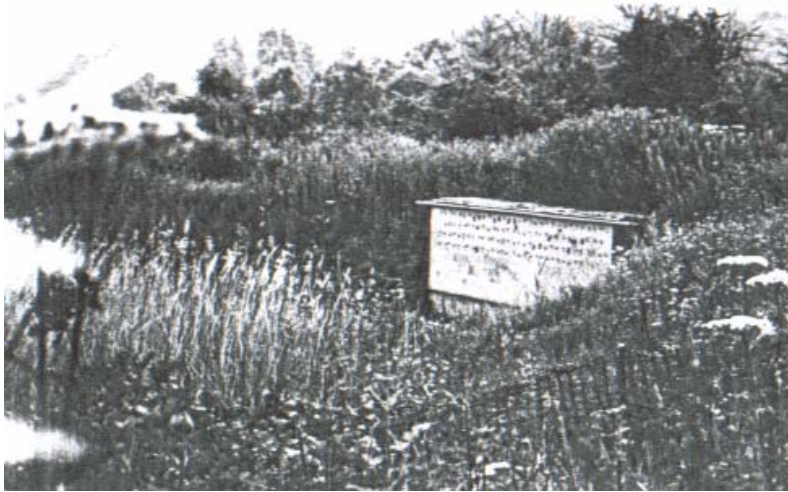
## Case Study 7

This bank is made with a concrete block wall in front of a sealed rear chamber filled with sandy loam and a roof on top. Water flows to the foot of the wall. This bank was completed in Spring 1999.

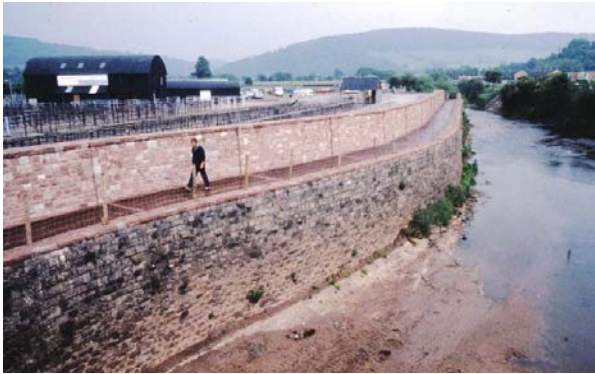
## Case Study 8

Although not purpose built for sand martins the stone retaining wall of the cattle market in Monmouth has been occupied by several birds. The wall looks out over the river and has four inch diameter clay pipes built into it, and the entire top row of these were occupied a few Years ago.

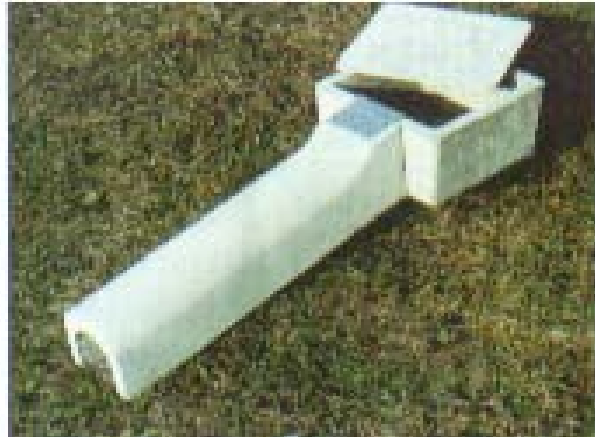
A ready made Kingfisher box designed in close consultation with leading bird experts made by Schwegler. This box costs £54.95 (2000 price) and is ideal for sinking into a site. It also has an inspection hatch for checking and cleaning.
